# VISITOR AND COMMUNITY NETWORK SERVICES SWITCH 100 RELEASE NOTES

These release notes relate to software version 1.00.

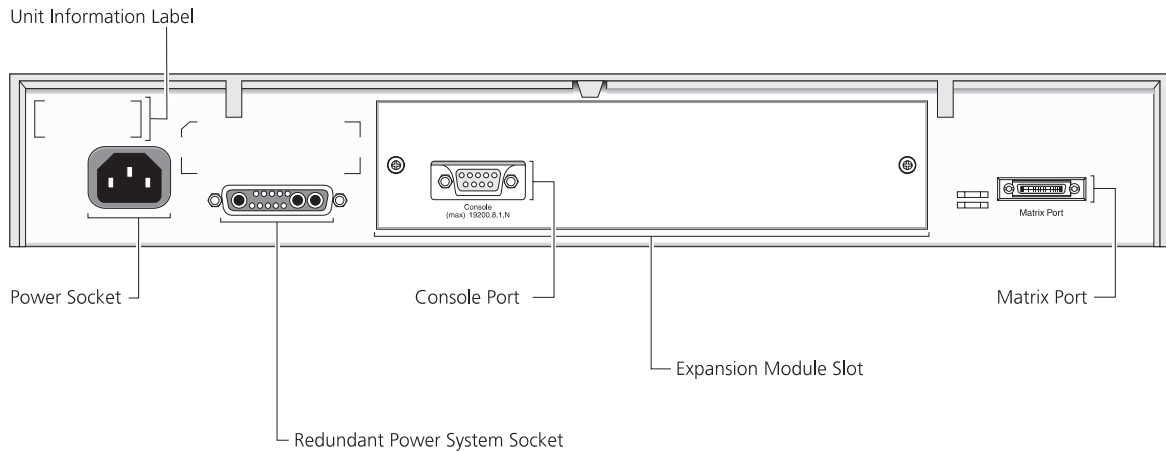
**Figure 3** VCN Services Switch 100 - Rear View

- 1 Expansion Module Slot** - An expansion module is not supported in this release. The VCN Services Switch 100 does not support any of the SuperStack II expansion module types.

The Expansion Module Port Status LED at the front of the switch will be off.

- 2 Matrix Port** - The matrix port is not supported in this release. It will not be possible to stack switch units by using a matrix cable or a matrix module.

The *Unit* LEDs at the front of the switch will be off.

*A blanking plate covers the slot in this release to ensure proper use of the switch.*
